Repair of hangar damage for the Trailing Edge of the elevator of the Jora UA2.

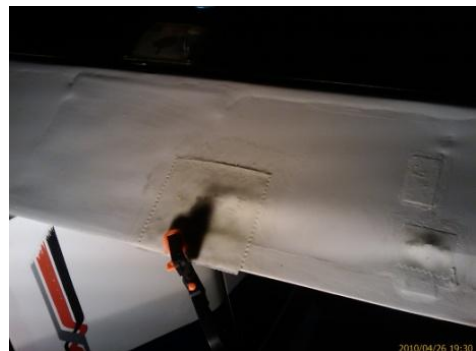
patches were trimmed, sanded and painted. Visually the repair looks fine and is strong. The treatment of heat did shrink the cover back to normal.
