Repair of hangar damage for the Trailing Edge of the elevator of the Jora UA2.

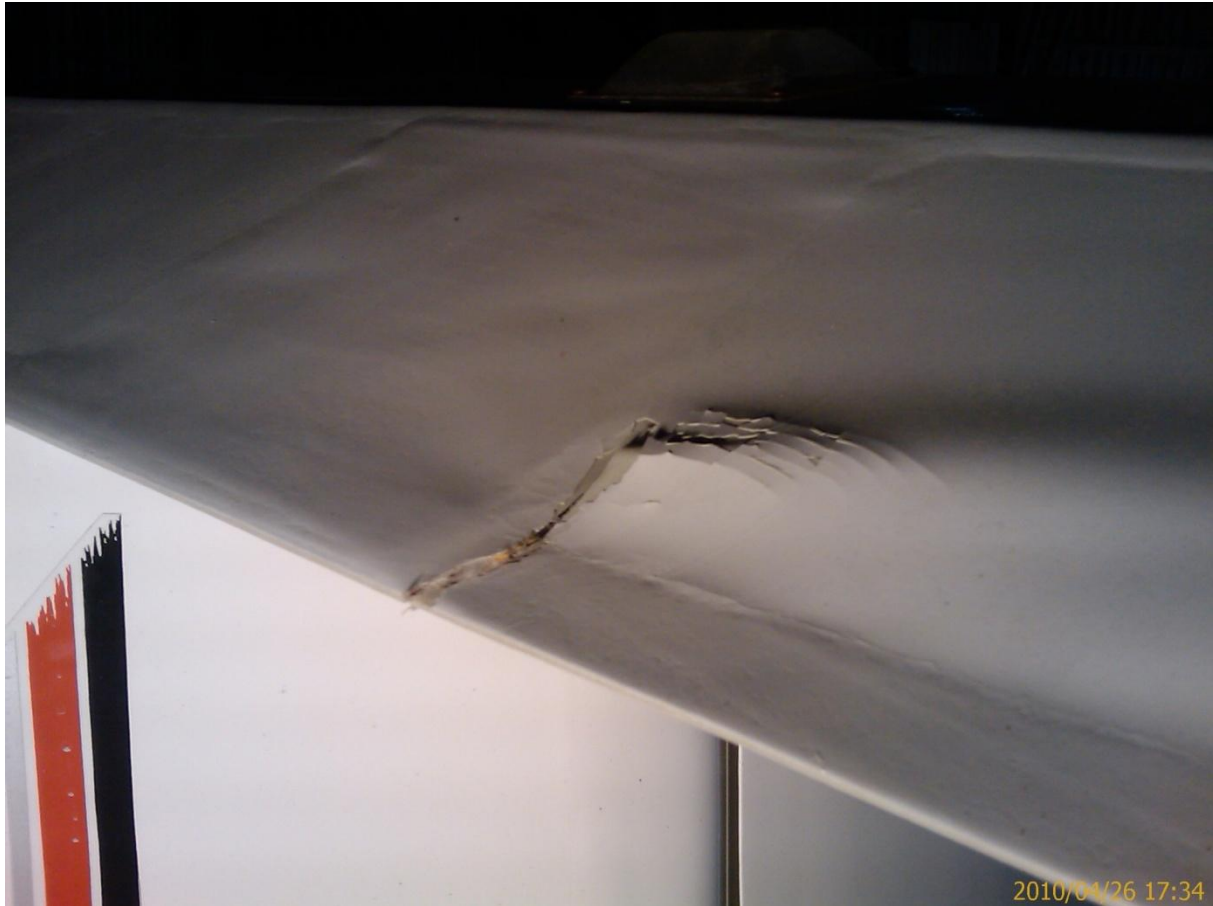
The elevator TE of a Jora UA-2 consists of two wooden profiles glued together in a V-shape. The damage was a fracture of these wooden profiles, and it was necessary to glue the profiles together reinforced before the cover was repaired with a patch. A typical hangar damage when moving the plane around. The elevator rests on the top of fin, and such a fracture can easily happen.

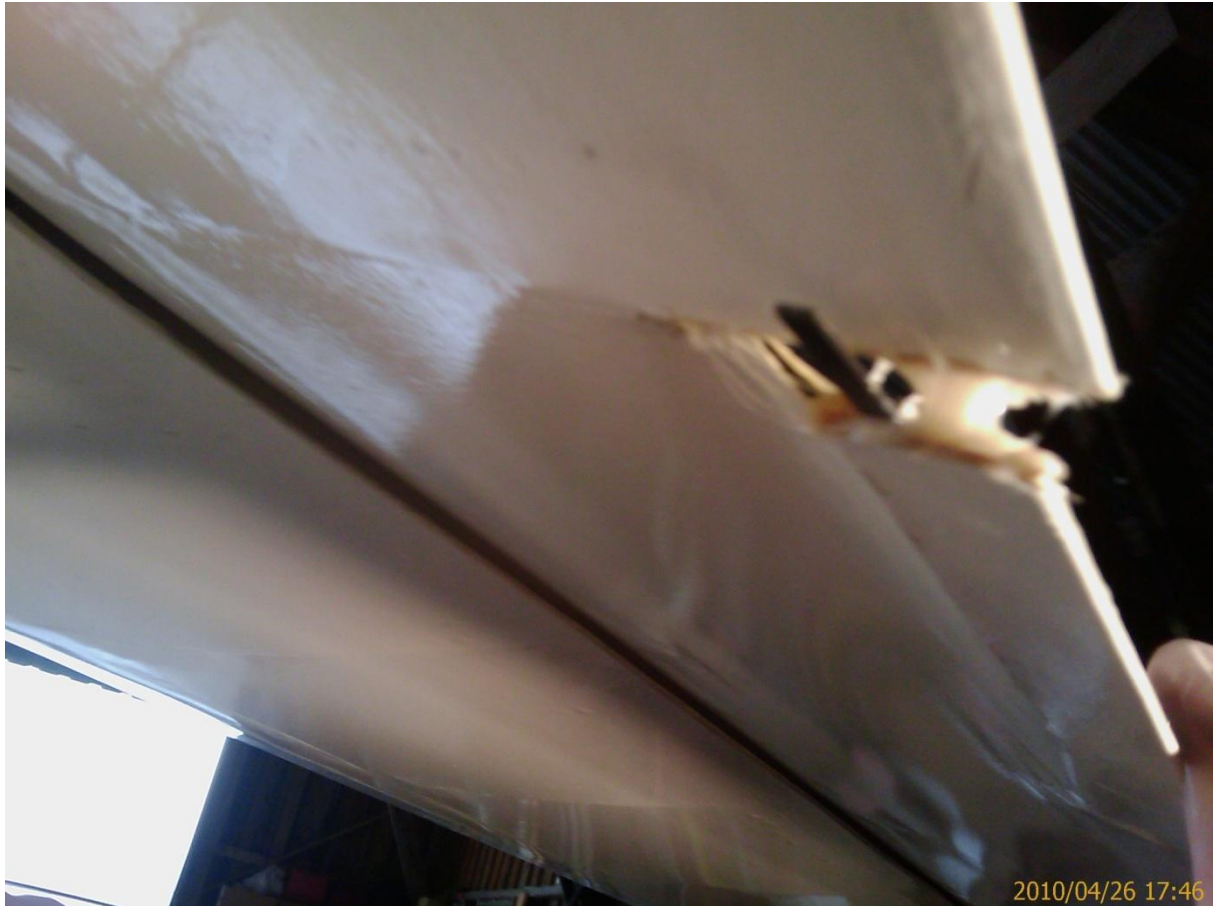
The picture below shows where the carbon rod was mounted. The rich layer of epoxy inside the V-shaped TE and around the carbon rod is visible in the damaged area.

The rod was pushed all the way in on one side before the joint were held together in the correct position. Then a tiny model builders knife was used to pry the rod back into the opening of the other side. The rod was mounted approximately centered with 50 mm on each side of the fracture.
