REPORT ABOUT FINDINGS - LOOSE BRACKETS

FOR TAIL WING IN JORA UA2 1995 – BUILD no. 008

Author: Harald Sakshaug, Nedre Sørliveg 1, 7712 Steinkjer, Norway

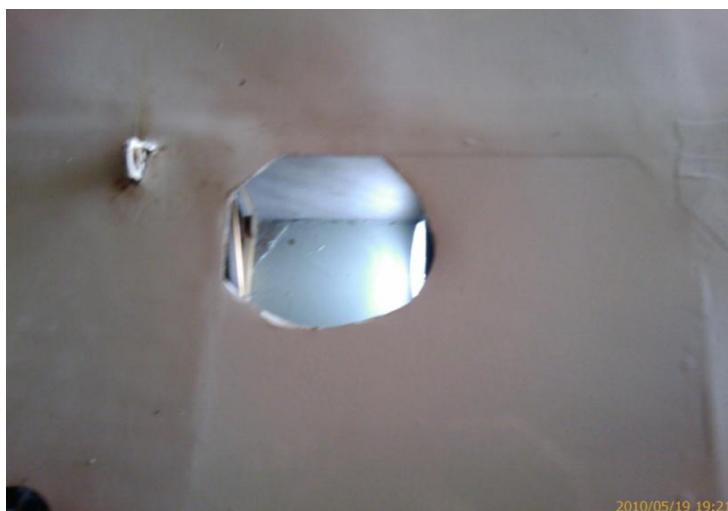
On the opposite side of the wooden central beam, hidden inside a D-formed torsion case, were the nuts used to connect brackets to the tail wing. The wing is made from a central plywood beam with a D-shaped fiberglass leading edge. This is a construction which does not allow the nuts to be accessed without cutting a hole.

Openings for inspection was made in the cover material from underneath. This was as agreed with the factory as the best procedure. To reinforce these holes, a rip stop ring was glued and sealed. One inspection hole for each side was made.

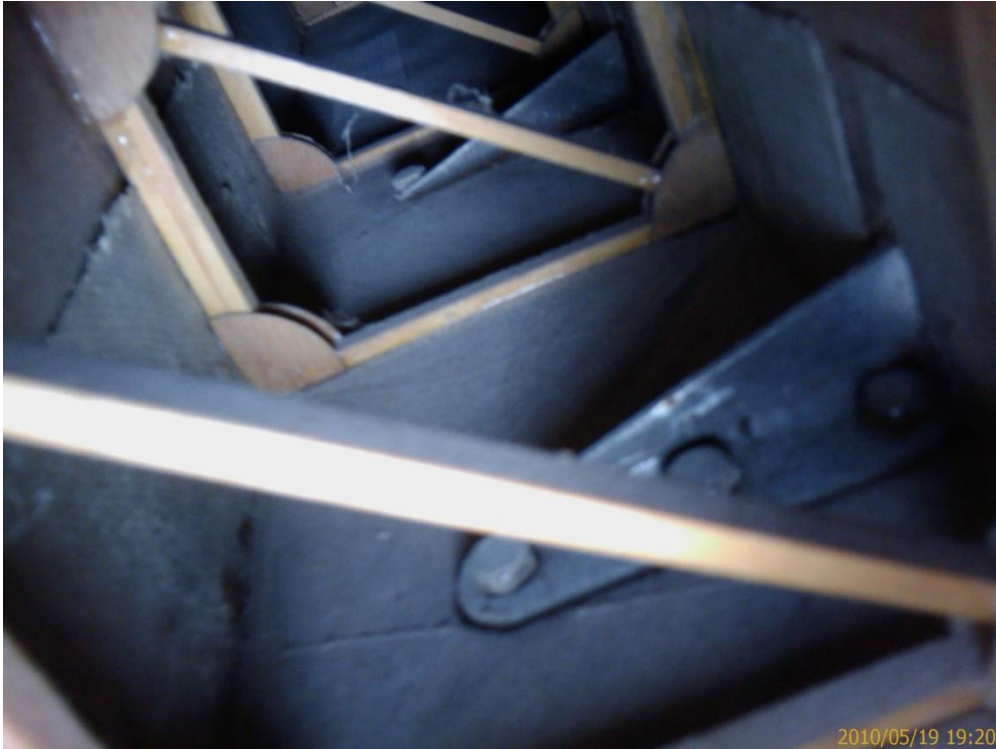
The wooden central beam had expanded during seasons of cold and wet, and made the bolt nuts work themselves into the wood a little. This then led to be loose brackets which in turn led to play in the fixture of the tail wing.

View of the inside fastening of the brackets before disassembly. There is no trace of glue, and the bolts are rather loose due to the plywood beam have expanded with temp. and seasonal changes.

Bolts and nuts was dismantled, and the brackets were pulled out from inside into the wing. This is a cumbersome job, since the front of the tail wing has access into the 6x12x12 cm boxes through the described 42 millimeter holes only. It is a bit of work, but not impossible if one is a bit creative, patient and create tools which will fit inside the rather tiny and small areas.

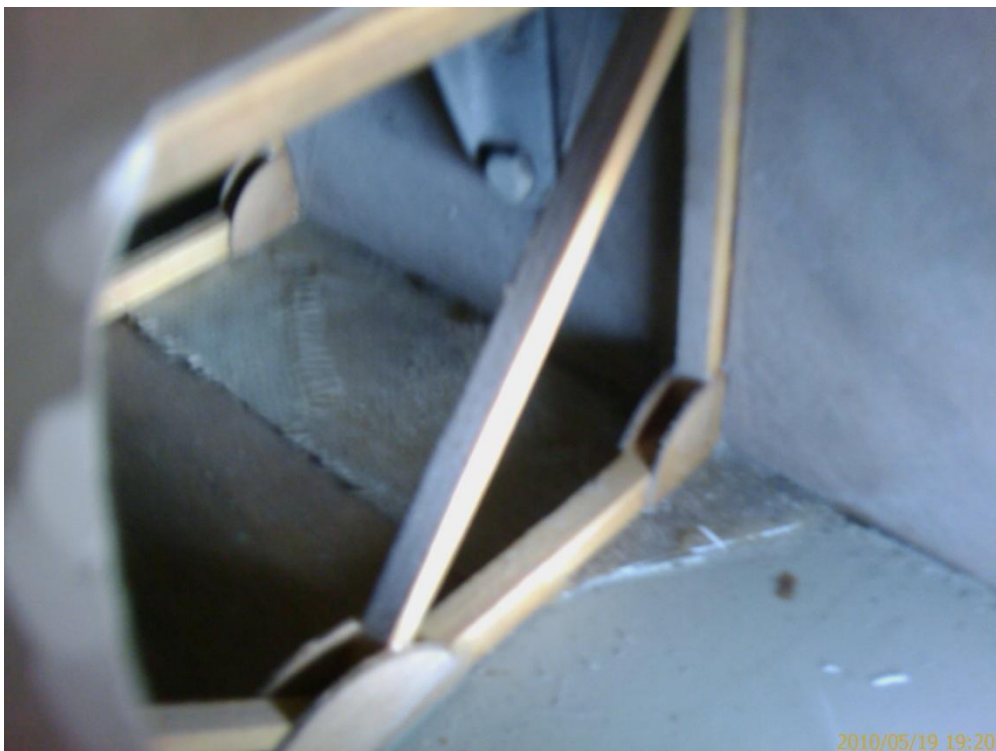
Apart from the fact that the brackets are loose, everything else looks good. Wood and glue have a good quality and there are no traces of damages. It appears with certainty that the bolts have worked loose due to vibration and seasonal changes, and not from a structural damage or overload.
